प्रारंभिक व्यावसायिक परीक्षण रिपोर्ट INITIAL COMMERCIAL TEST REPORT

संख्या/No. CSIR/CMERI/FMTTC/2025/014 भाह/Month: March, 2025

# AL-BURHAN INTERNATIONAL BRUSH CUTTER (MODEL NO. - BC 43 SP)

# **AL-BURHAN INTERNATIONAL BRUSH CUTTER** (MODEL NO.- BC 43 SP) (INITIAL COMMERCIAL TEST)

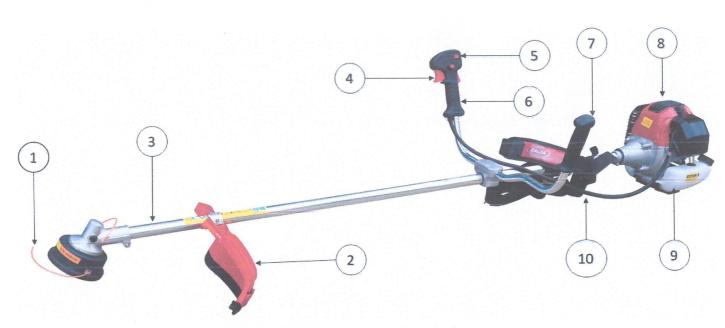
Fig. 2: Schematic View of Brush Cutter

- 1. Nylon rope
- 4. Throttle cum clutch lever
- 7. Left Hand holder
- 10. Shoulder belt
- 2. Grass deflector
- 5. Emergency engine stop switch
- 8. Engine

- 3. Frame pipe
- 6. Right hand Holder
- 9. Fuel tank
